Instructions for QBM CBV Upgrade Kit

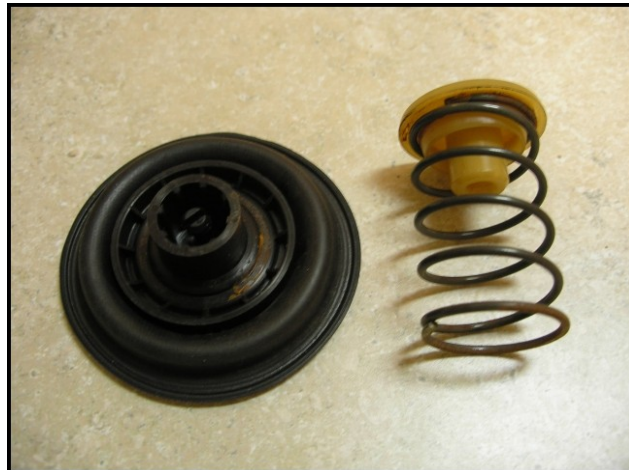
2. Once removed, wipe the CBV off using a clean rag. Pull the rubber CBV diaphragm from the metal case by gently tugging on it. Next hold the CBV diaphragm with one hand and the yellowish plastic seat with the other hand and gently pull straight apart. Once apart you will be left with the following:

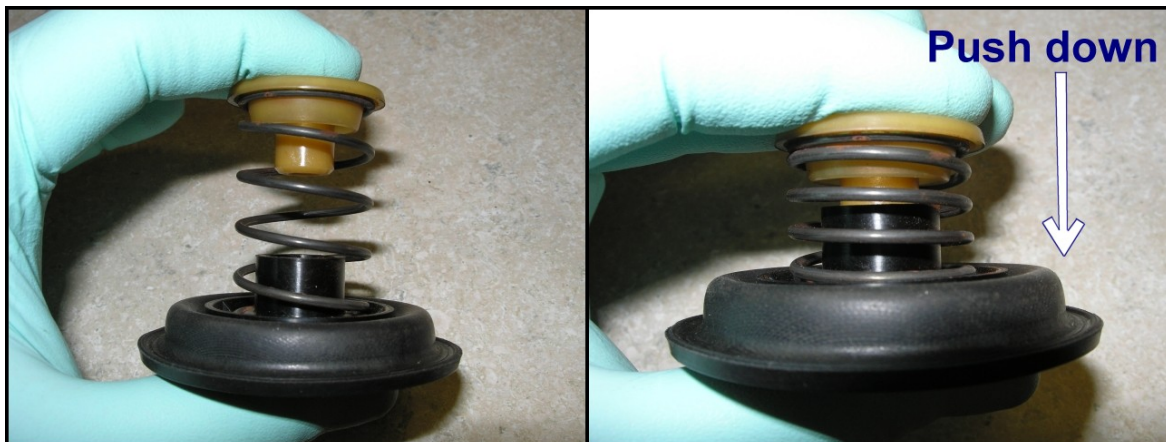
3. With the CBV diaphragm now disassembled, place the spring and seat onto the new CBV diaphragm, and snap the seat down onto the CBV diaphragm as shown:

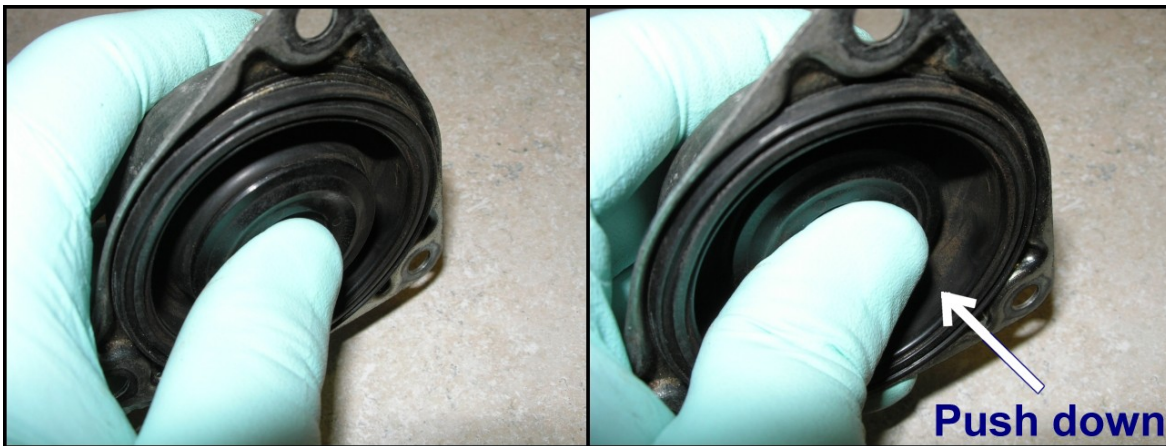
5. Insert the shims into the bottom of the metal CBV case. Reinstall the CBV diaphragm into the CBV case, making sure the yellowish diaphragm seat is seated straight and fully. Bottom the CBV diaphragm seat into the case by pushing down on the center of the CBV diaphragm, fully compressing the diaphragm spring as shown. You should feel the CBV seat into the CBV case. See photo:
